Sydney Water Trial Project Using Low Voltage Conductivity to Assess Sewer Pipe Water Tightness

Chuck Hansen¹, Michael Condran, PE², Toby Bourke³

EXECUTIVE SUMMARY

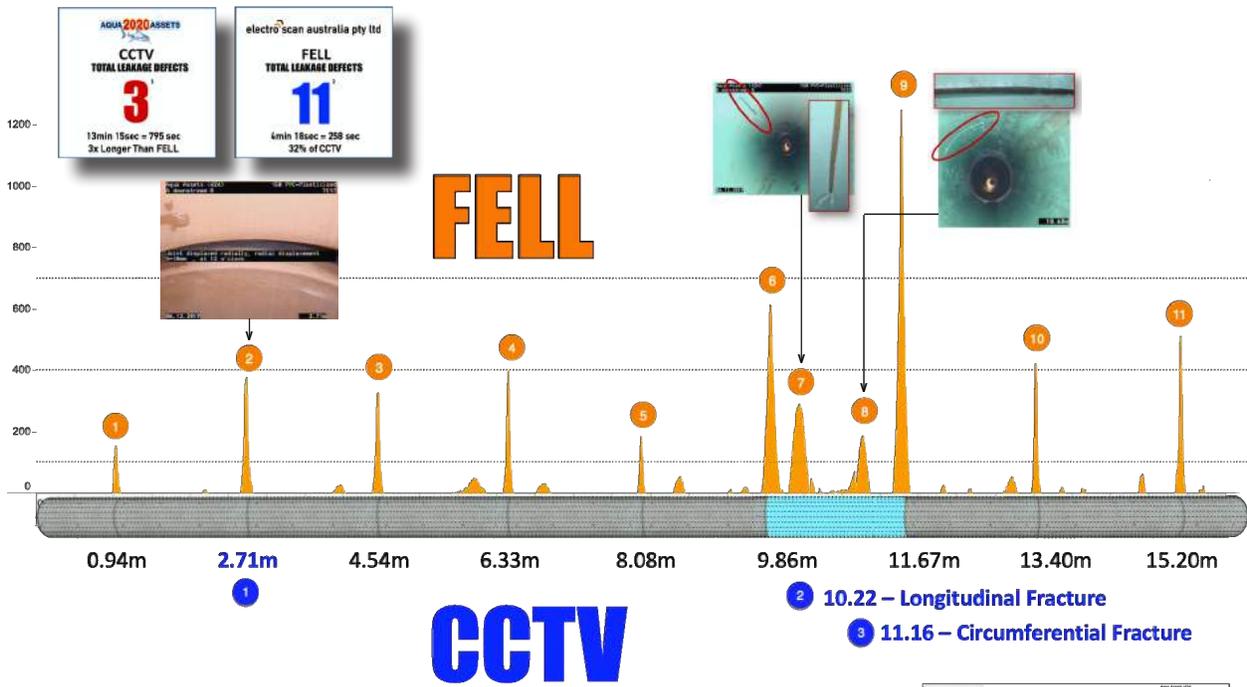
As shown above in Figure 16 (Above), CCTV recorded three (3) defect locations, including (a) displaced joint at 2,71m, (b) longitudinal fracture @10.22m, and (c) circumferential fracture @ 11.16m, with both defects at (b) and (c) placed by Sydney Water staff. Once fully set-up with the camera positioned in the pipe CCTV inspection took 13 minutes, 15 seconds to complete its inspection.

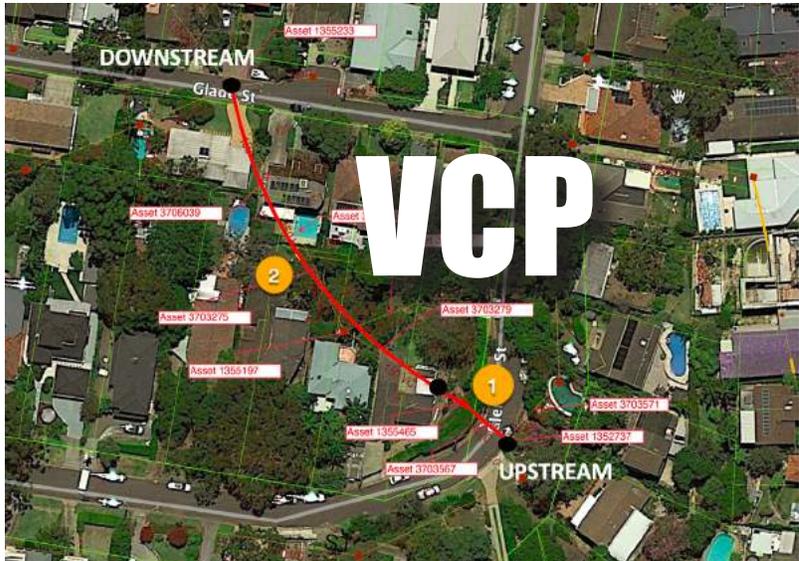
Despite a collapse found by CCTV in #1, difficult to access manhole entry was easily overcome to allow both CCTV and FELL inspections; however FELL automatically surveyed leaks at nearly every VCP pipe joint, fractures, and junctions.

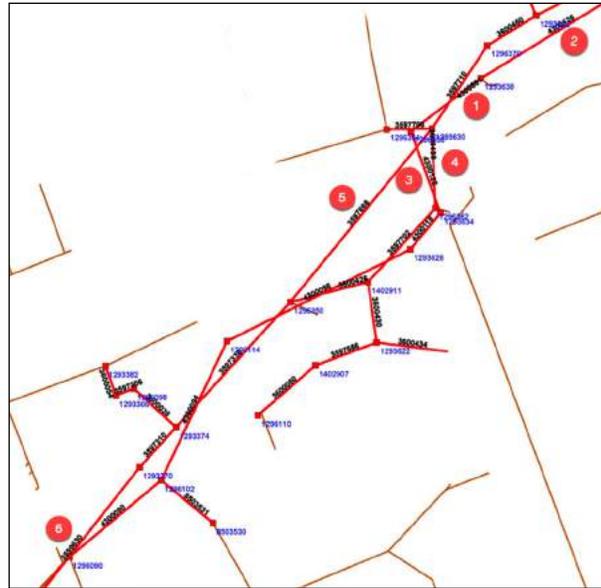
In addition to surveying its two longest sewer mains (i.e. 97m and 85m), Electro Scan survey its only Spiral Wrap Liner with a Rib-Loc system (#1) and a deteriorated sectional CIPP as part of a VCP (#3). While there were a number of CCTV observations, few if any material sources of infiltration were visually located.

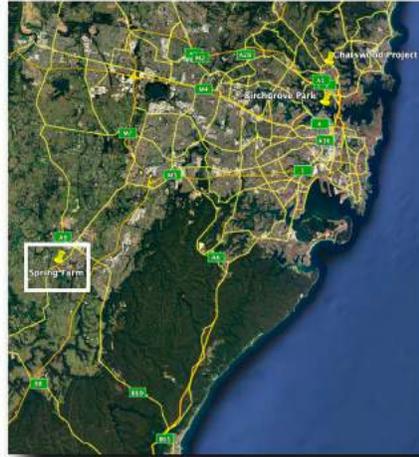
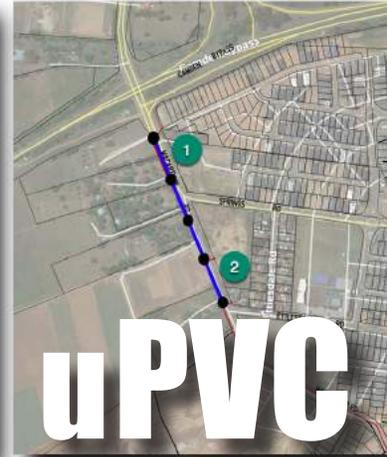
While Spring Farm's uPVC had near perfect readings, several small spikes suggests that slight water leaks may occur at locations designated by FELL reporting. We also understand that there is a material change within 1m of the manhole, and that pipes has not yet passed vacuum testing.
