Condenser and Heat Exchanger
Restoration Systems

Oil Refinery Crisis Averted Thanks To Tube Restoration

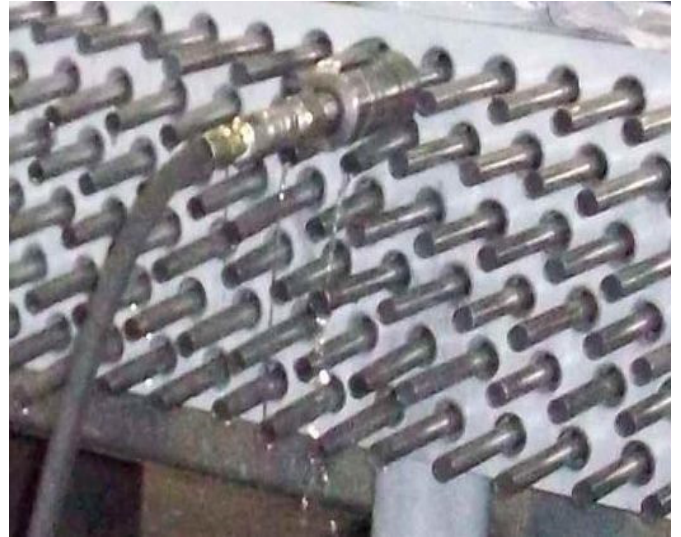
The installation process began by inserting Liners into all tubes, with their ends protruding from the header box plug holes (see photo). An expansion chuck - connected to CTI's custom air powered hydraulic Liner pump - is attached at one end of the Liner while a bleed chuck is affixed to the opposite end. The Liner is filled with water and the air is released. The pump pressurizes the water until the Liner is expanded full length to a contact fit with the existing tube I.D.'s. When the expansion process is completed, Liner ends are cut and trimmed flush to the tube ends, then roller-expanded at each tubesheet.
