White Paper: Coating Test Results for Salt Water Valve Applications

PRATT
Henry Pratt Company

A report on a test, its results, and conclusions following the saline spray exposure of a Pratt 24-inch Butterfly Valve coated with PrattGuard 200 on critical surfaces. The valve body and disc, which are of ductile iron construction (ASTM A-536 (65-45-12) had seals added to the valve body and disc shaft bores via additional machining, to prevent intrusion of the flow media into these areas.

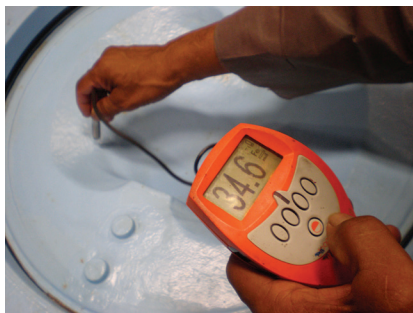
Readings of the coating thicknesses in the concave portions of the disc where the salt water had pooled were also taken. No signs of damage were observed and the coat thickness readings were very favorable.
