## **Bio-Augmentation Product Eliminates Odor and Removes Sludge from Waste Lagoons**

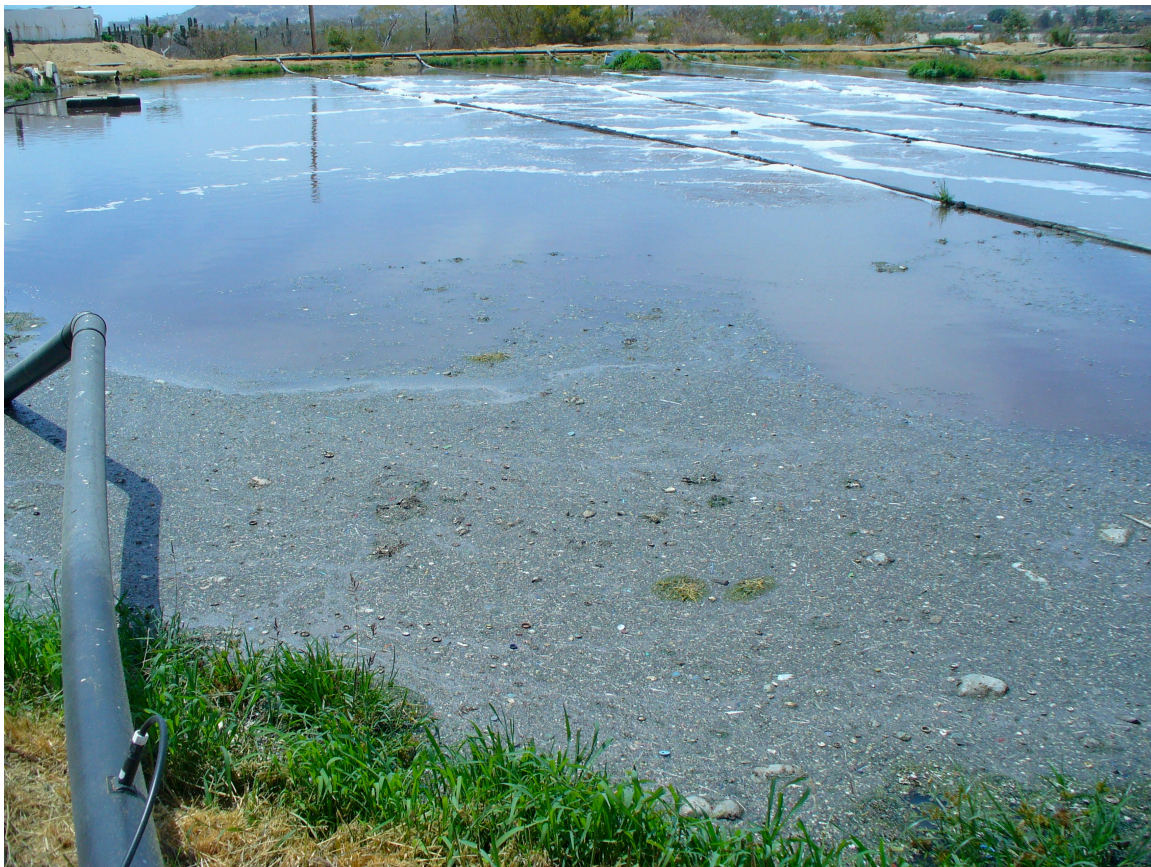
The segmented lagoon system for the waste facility is over 20 years old and utilizes a linear fine bubble aeration system. Over the years some of the diffusion hose and aeration equipment quit working for various reasons and sludge built up on the outside edges of the lagoons, resulting in short circuiting. The ensuing sludge buildup eventually broke the surface of the water, causing intense odor problems. Due to the proximity of the golf course to the lagoons, the odor made a round of golf somewhat of a challenge, but, more seriously, a north wind would carry those odors into the town and its hotels.

**Figure 1** – Short circuited lagoon with exposed sludge buildup around the edges.

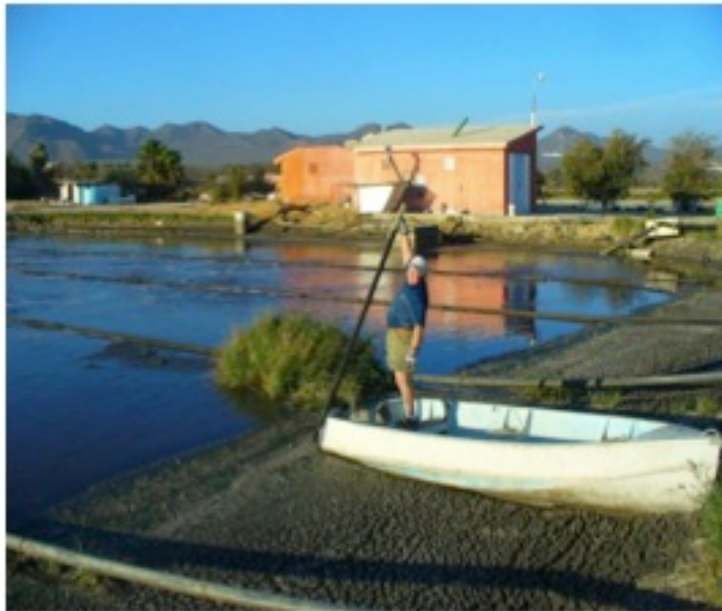
**Figure 2 –**  
A sludge measurement approximately five feet from the shore of the lagoon measured over 7 feet of sludge depth. This depth was very consistent around the edges of most of the lagoon.

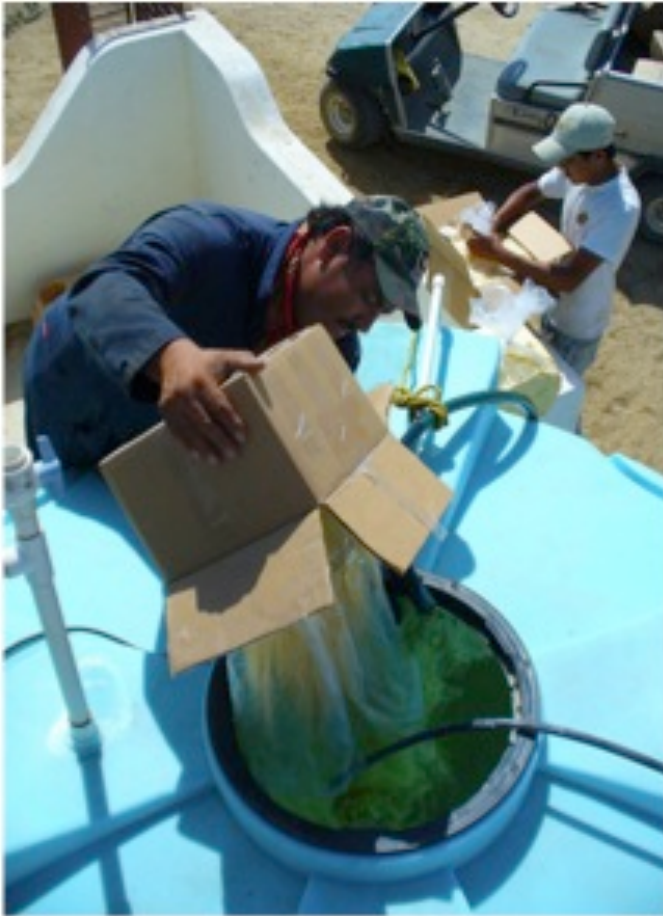
CIASA utilized a 25,000 gallon flow stabilization tank for the inoculation of the Sewper Rx bacteria. The granular blend was poured into the tank that was filled with normal tap water, and mixed. It was allowed to 'activate' for several hours,

**Figure 3 –**  
Premixing of the granular Sewper Rx sludge digestion product was performed in a 25,000 tank prior to pressure injection of the hydrated bacterial solution into the sludge.

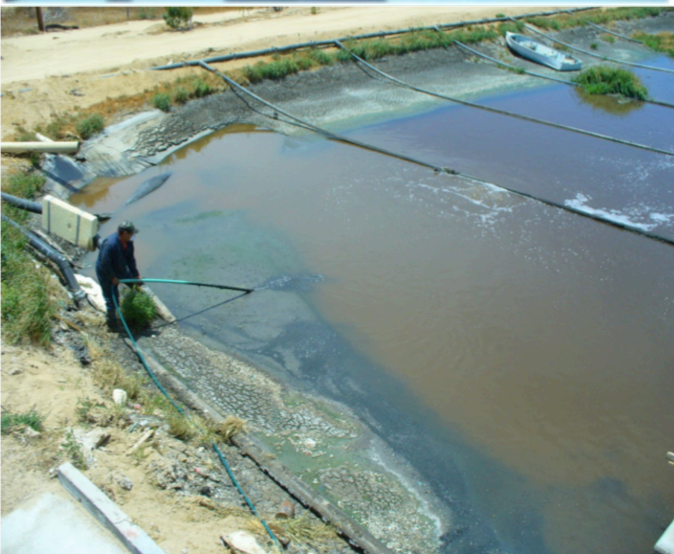
and the next morning technicians began pressure injecting the bacteria into the sludge at a number of depths. (Figures 3 & 4) Sludge injection for each lagoon took approximately 375 pounds of Sewper Rx and it took approximately 7 days to complete the injection of each lagoon.

**Figure 4 –**  
Pressure injection at many depths into the sludge was performed by technicians. Each lagoon took approximately 7 days for complete inoculation.

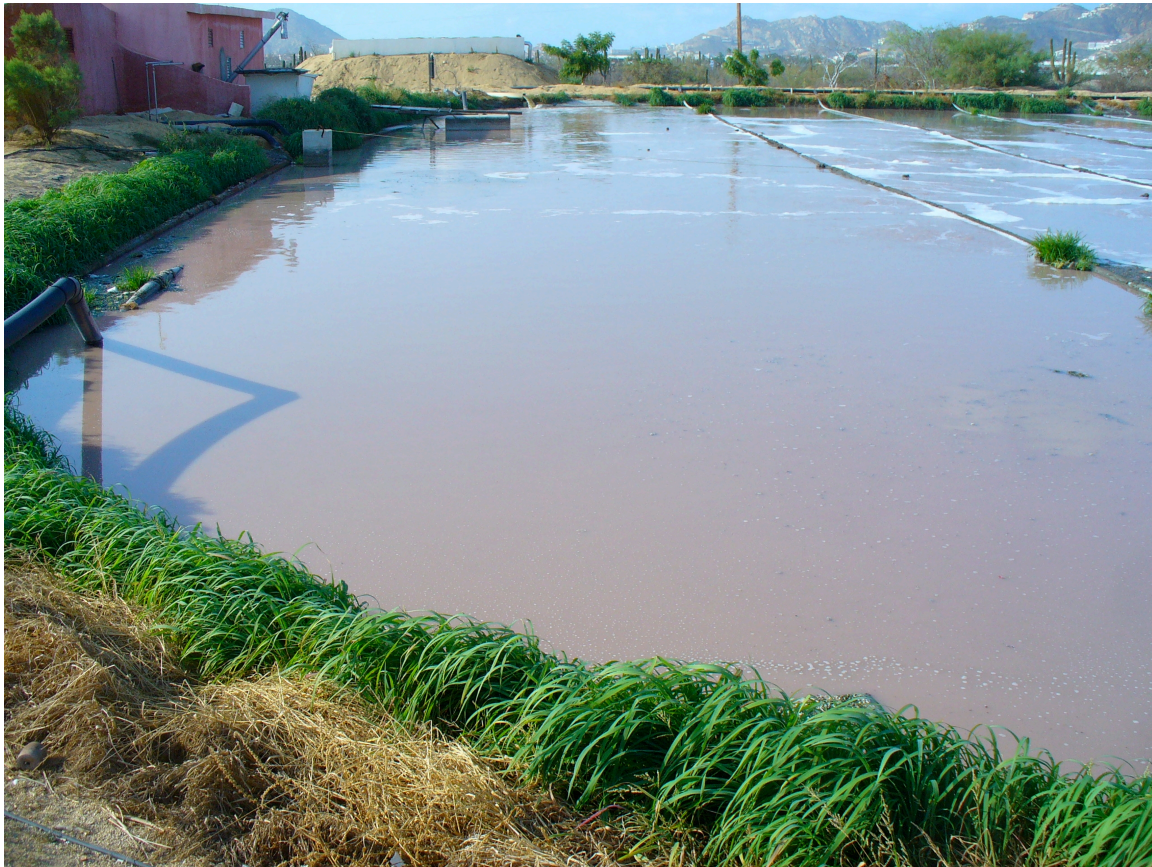
Within 72 hours of treating each lagoon, sludge odors were notably reduced. Odors remained abated. Within 60 days the sludge above the normal water line of the lagoons had dropped to below the water. (Figure 5) At the 90 day mark the sludge reduction was measured around the shoreline of each lagoon and an average of 1.8 feet of reduction in sludge depth was realized. It should be noted that the lagoons remained active and on-line throughout this treatment process.

**Figure 5** – A photo from the exact same location as Figure 1, taken approximately 70 days following treatment of the raw sludge by the Sewper Rx bio-augmentation blend of bacteria.
