# Water main rupture puts Florida community at risk of flooding

Smith-Blair tapped to design and produce custom-fabricated fitting for pipe repair

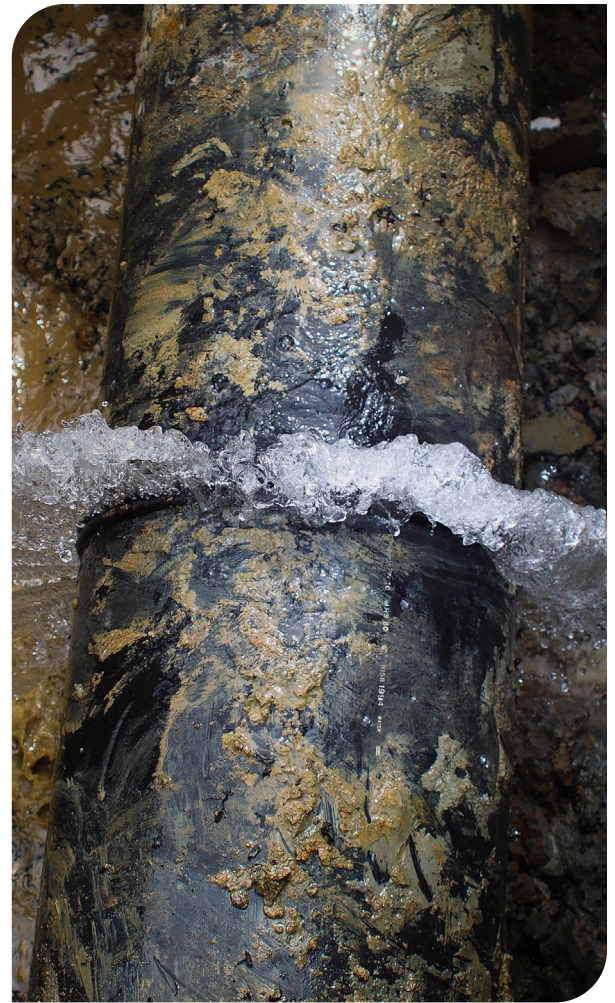
Since the fitting is one-of-a kind, Smith-Blair assisted with the installation and field testing. A team of professionals joined the utilities crew at the job site to ensure the fitting was properly installed and the project completed in a timely manner. Ultimately, crews completed permanent repairs in less than 10 hours with no interruption of water service for residents.
