Sydney Water Trial Project Using Low Voltage Conductivity to Assess Sewer Pipe Water Tightness

Chuck Hansen¹, Michael Condran, PE², Toby Bourke³

EXECUTIVE SUMMARY

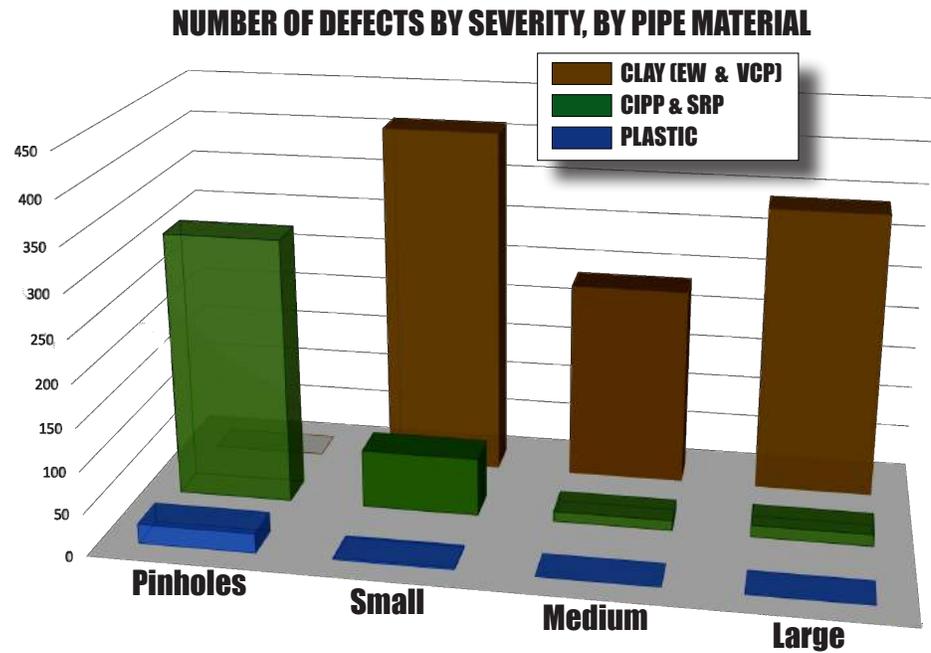
Figure 17. Number of Defects By Severity

Electro Scan found 1,421 Total Defects in 24 sewer mains, representing 116,409 liters per second of defect flow, with one sewer main repeated twice at Potts Hill for testing purposes.

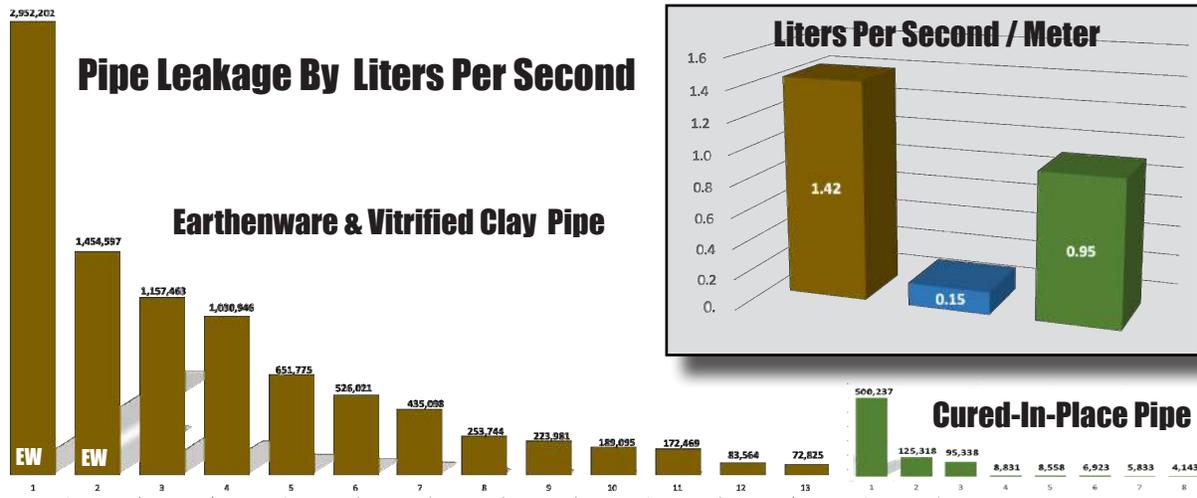
It should be noted that while defects counts and l/s defect flows for clay pipe appears consistent with older pipes, but defects found in newly installed CIPP appears excessive.

Scans	Distance	Pinhole	Small	Medium	Large	Total Defects	LPS	LPD
14	706	0	418	237	339	994	107.441	9,282,873

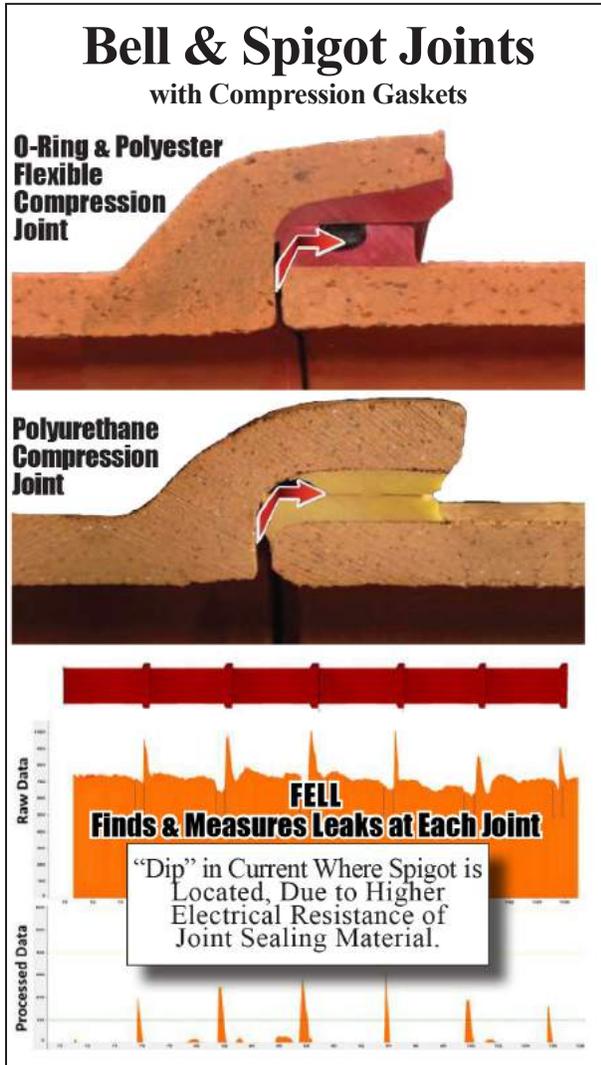
Figure 22. FELL Inspection of Bell & Spigot Joints

and vitrified clay (VC) pipe, which represents the most significant percentage of sewer pipe material in the utility's service area, and not capable of adequately assessing leak profiles at cracks or joints.

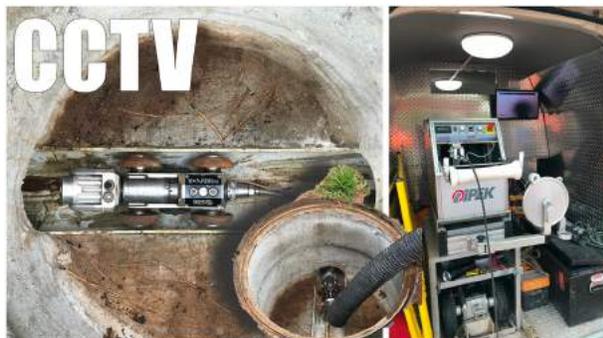
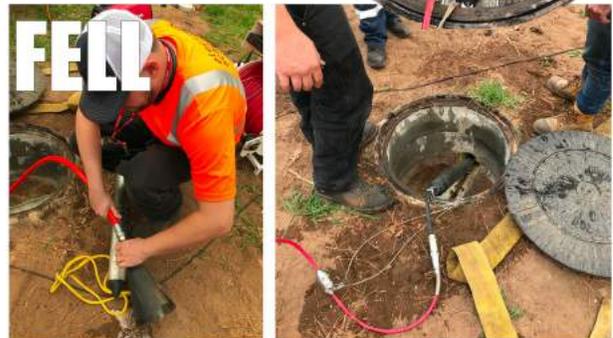
As shown above in Figure 16 (Above), CCTV recorded three (3) defect locations, including (a) displaced joint at 2,71m, (b) longitudinal fracture @10.22m, and (c) circumferential fracture @ 11.16m, with both defects at (b) and (c) placed by Sydney Water staff. Once fully set-up with the camera positioned in the pipe CCTV inspection took 13 minutes, 15 seconds to complete its inspection.

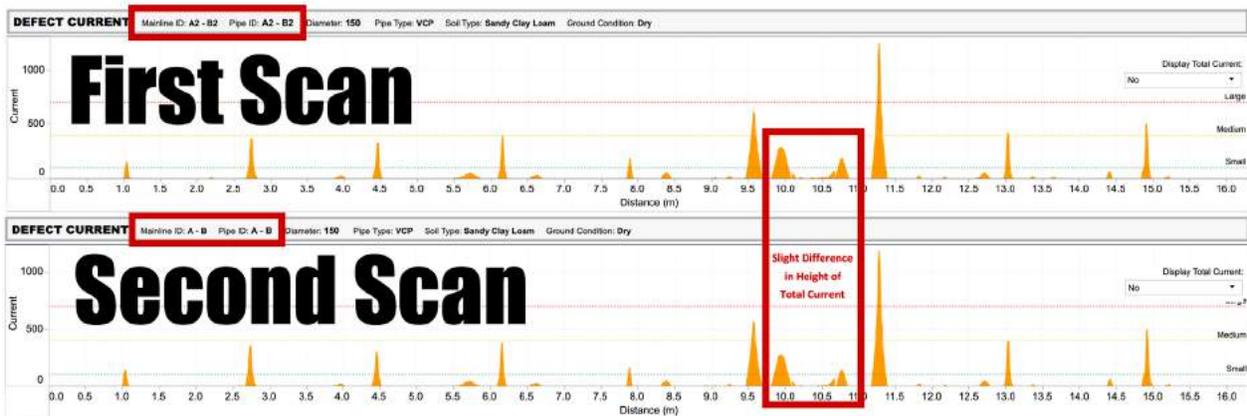
Two (2) of the 11 defects may have been influenced by a metallic flange in each of the ferno fittings, but separation of FELL results, indicates that 'no impact' was made on any other defects identified.

In contrast, FELL recorded eleven (11) defect locations, including leak locations at joints, defects at both changes in material, and both previously installed defects

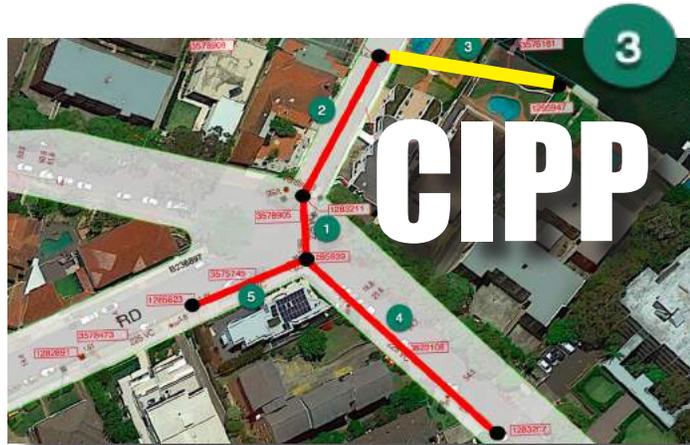
Each sewer main surveyed was 225mm diameter pipes, consisting of 5 pipes, including four (4) VCP and one (1) CIPP, with FELL finding over 409 defects with a maximum leakage rate totaling 19.596 l/s.

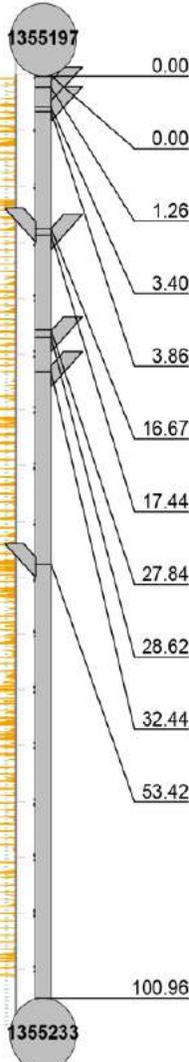
Despite a collapse found by CCTV in #1, difficult to access manhole entry was easily overcome to allow both CCTV and FELL inspections; however FELL automatically surveyed leaks at nearly every VCP pipe joint, fractures, and junctions.

Multiple or complex fracturing, width 2mm , from 10 to 2 o'clock

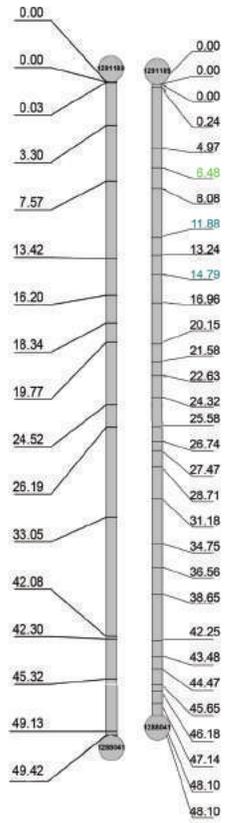
Defective lining, the lining is wrinkled, circumferential, reduction in cross sectional area: 5-20% , from 9 to 3 o'clock, Start

Defective lining, the lining is wrinkled, multiple/complex, reduction in cross sectional area: 5-20% , from 10 to 2 o'clock

Defective lining, the lining is bulged, reduction in cross sectional area: <5% , at 11 o'clock

Deposit is fine sediments- Sand or Silt in the invert , Obstruction: 5-20% , Cleaning Req for acc report, from 4 to 8 o'clock

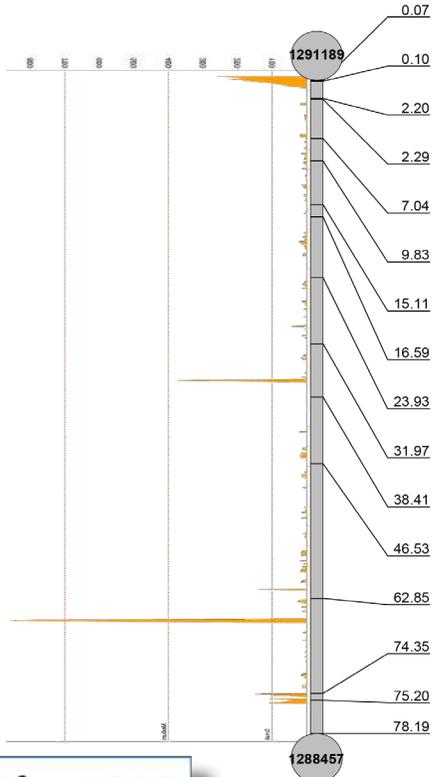
Defective junction, roots are growing into and/or down the connect conduit, magnitude of obstruction <5% , at 12 o'clock

Defective junction, roots are growing into and/or down the connect conduit, magnitude of obstruction 5-20% , at 12 o'clock
